Inspection Report

Minerals Regulatory Program

Mine Name: Allred Mine	Permit Number: M/049/0029
Operator Name: Interstate Brick Company	Inspection Date: May 14, 2013
Inspector(s): Lynn Kunzler & April Abate	Time: 10:00 AM
Other Participants: Tom Nicolaysen (intern)	Mine Status: Active

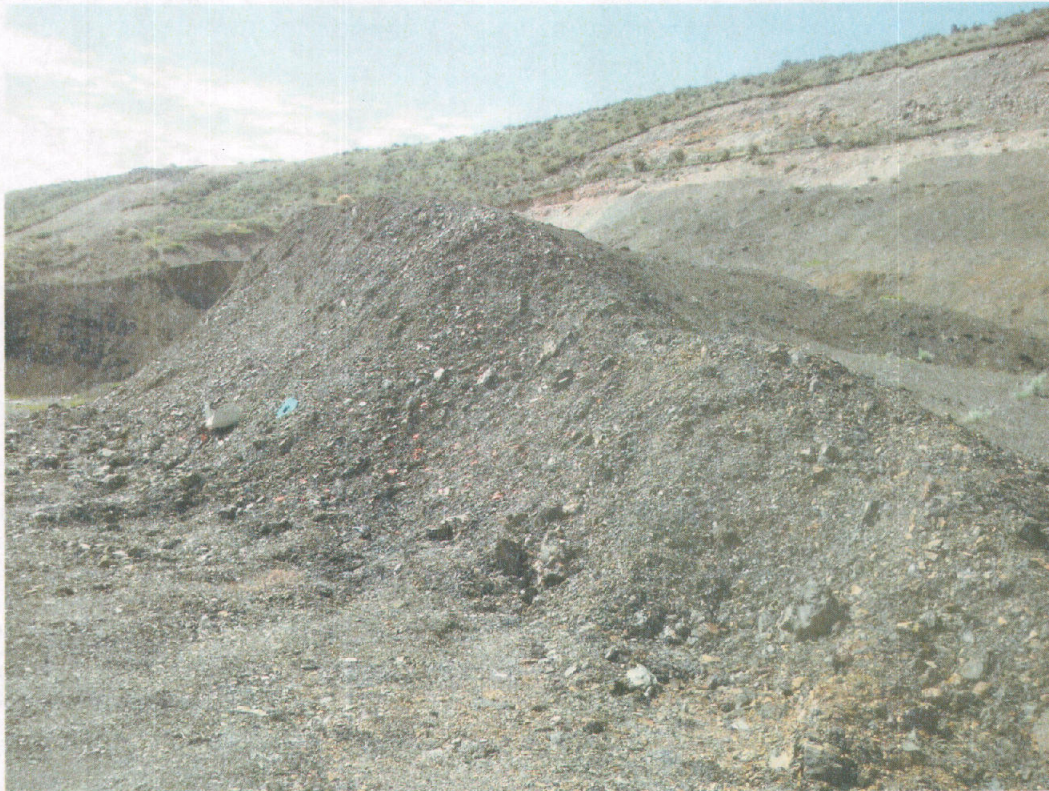
Figure 1. Clay stockpile at the Allred Mine Pit.

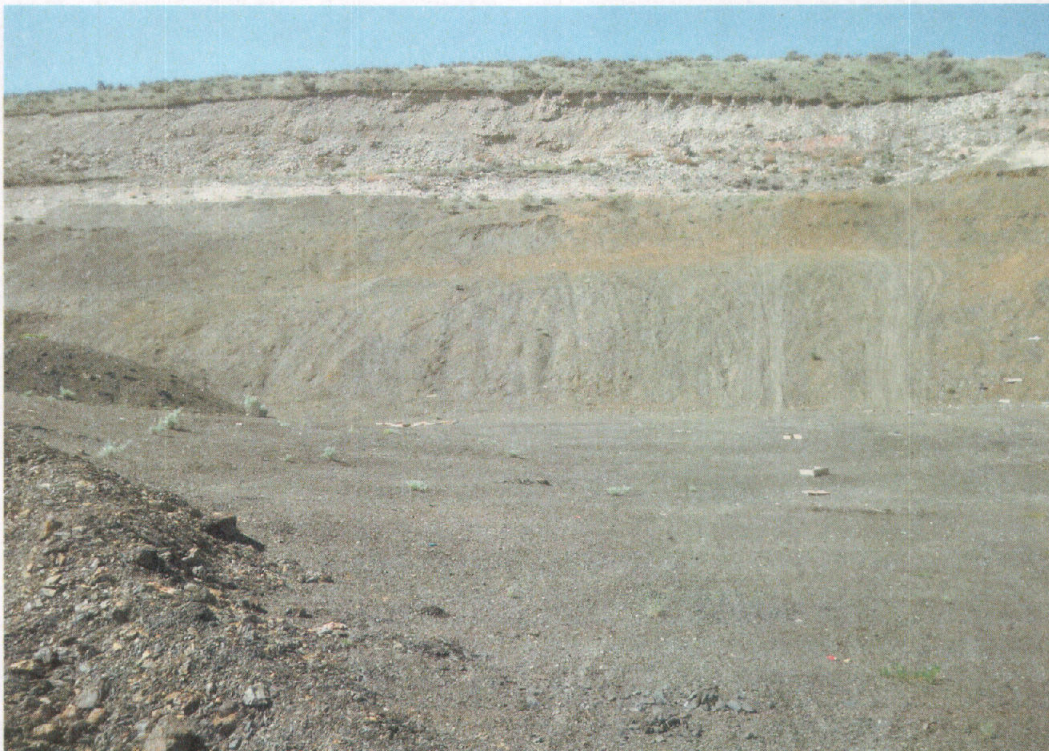
No operational activity was observed during the time of inspection. The operator mines the site approximately 3-4 weeks per year to build up the current stockpile of clay. A topsoil pile was noted at the site. The pit high wall looked as if it was unstable in some areas. Lynn indicated that failures of the high wall have occurred in the past. Two large puddles of standing water were observed in the pit area. Water was contained in the puddles and not migrating off property. Some trash in the area had been burned.

Figure 2. Highwall at the Allred Pit

Review mine plan for high wall design specifications to see if the current high wall is compliant. A follow up inspection might be needed. *Note: Approved NOI dated Mar 28, 2006 states that highwalls are to remain greater than 45 degrees and 3H:1V.*

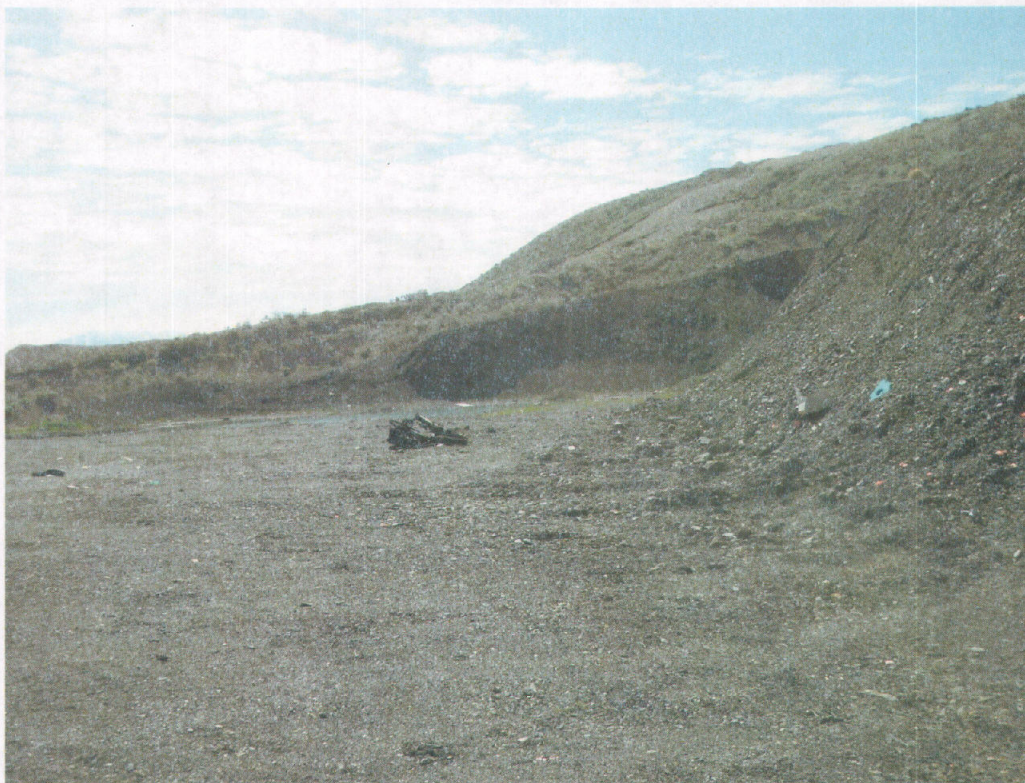
Figure 3. View of Highwall looking east.
